# Navajo Abandoned Uranium Mine

## Site Screen Report

### Joe Ben 2 AUM Site

**March 2010**

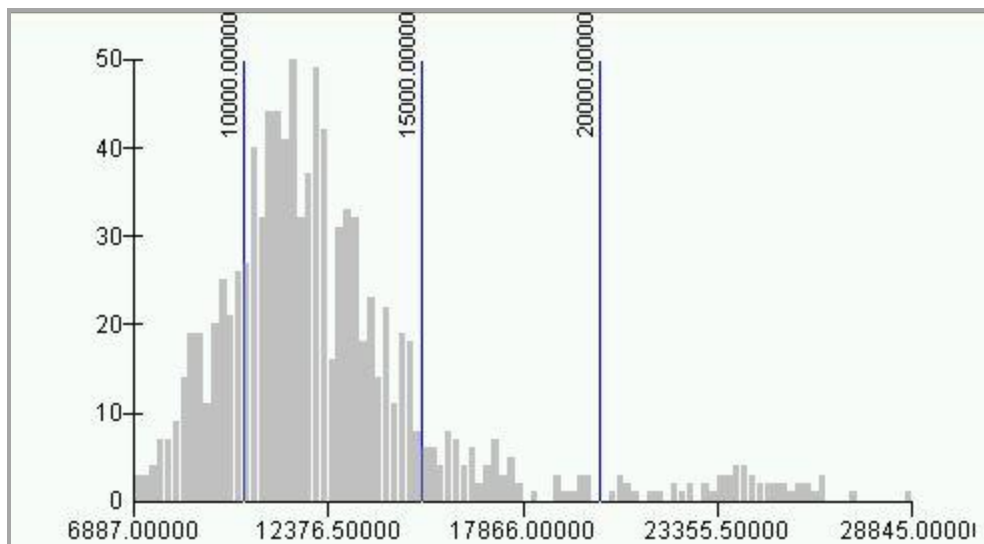
The following chart and statistics were generated by ESRI ArcGIS 9.3.1, and show the general distribution of the site gamma radiation measurements. The horizontal X axis represents the gamma radiation reading levels in cpm (lowest levels to the left). The vertical Y axis represents the frequency of each gamma radiation level.

Count:	1000
Minimum:	6887.00000
Maximum:	28845.00000
Sum:	12441219.00000
Mean:	12441.21900
Median:	11730.50000
Standard Deviation:	3510.31642

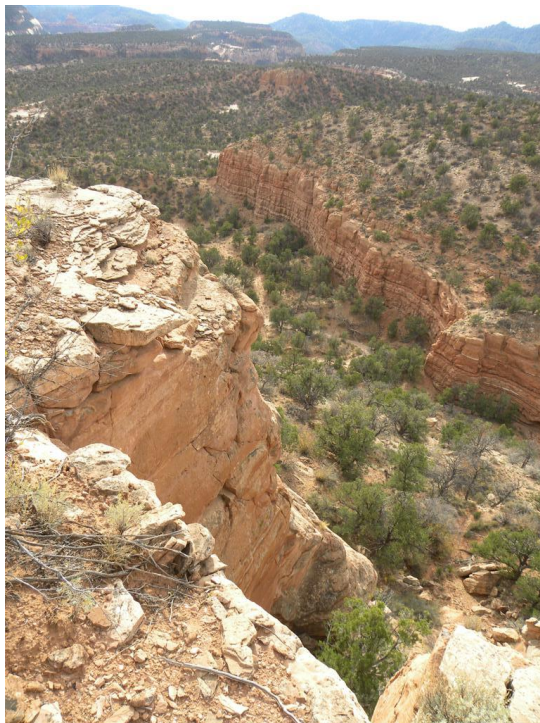
Photo 1. Direction towards mine site

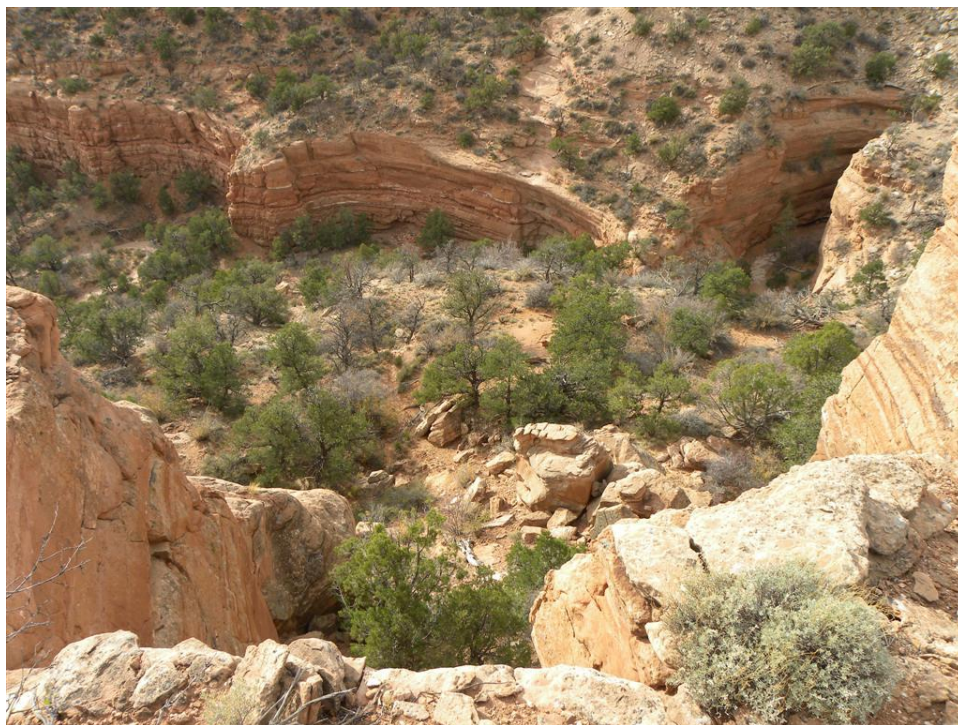
Photo 2. Direction towards mine site

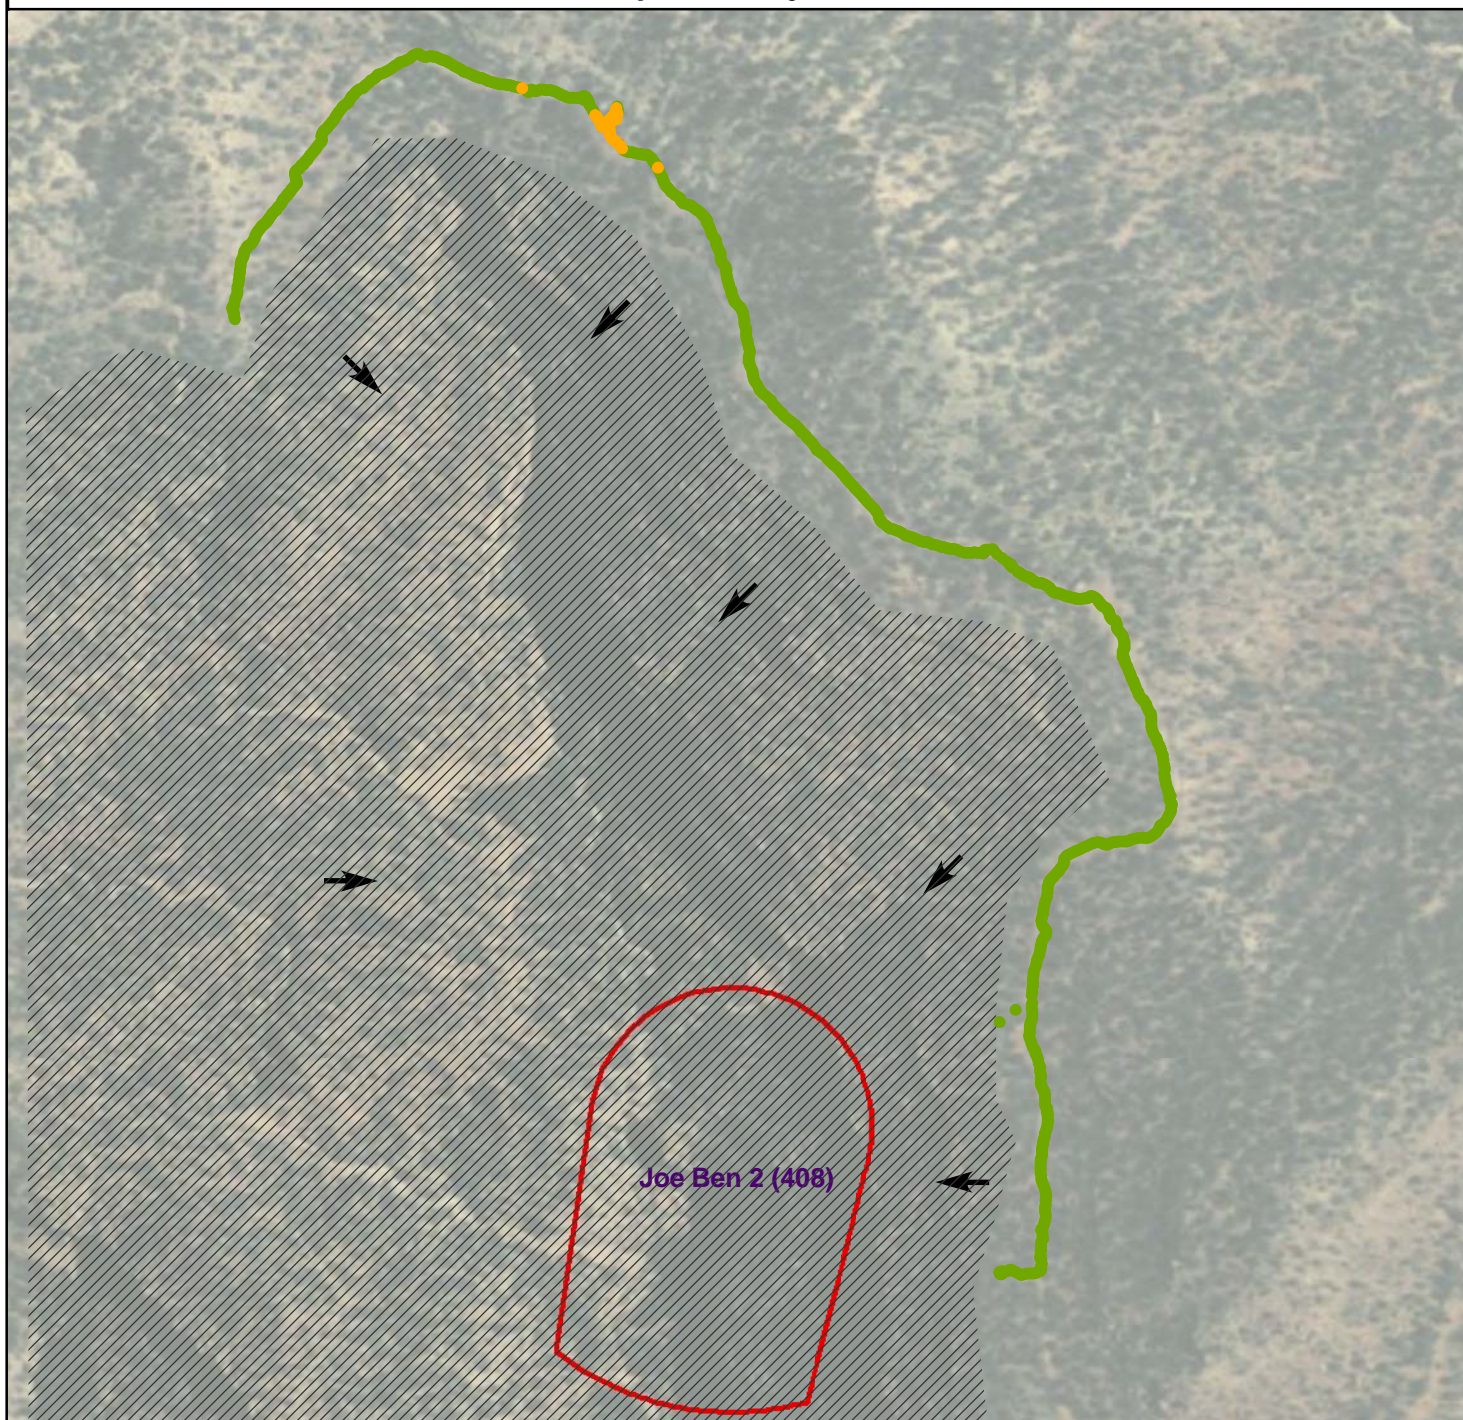
**Figure 1 - Gamma Radiation Measurements, Above Two Times Background  
Joe Ben 2 (408)  
Sanostee Chapter, Navajo Nation, Arizona**

Weston was unable to access the site during the October 2009 site screenings.  
All known paths leading towards the site were impassable. See site screen report for documentation.

Gamma survey conducted 10/2009  
Measured as counts per minute (cpm)

Average background = 9,300 cpm

Weston was unable to access the site; due to steep grades all known paths to the site were impassible. Measurements were collected in the vicinity of the site, approximately 200' east of the site boundary. A total of 1,000 gamma radiation measurements were collected near the mine site, ranging from 6,887 cpm to 28,845 cpm. The measurements are represented in Figures 1 and 2.

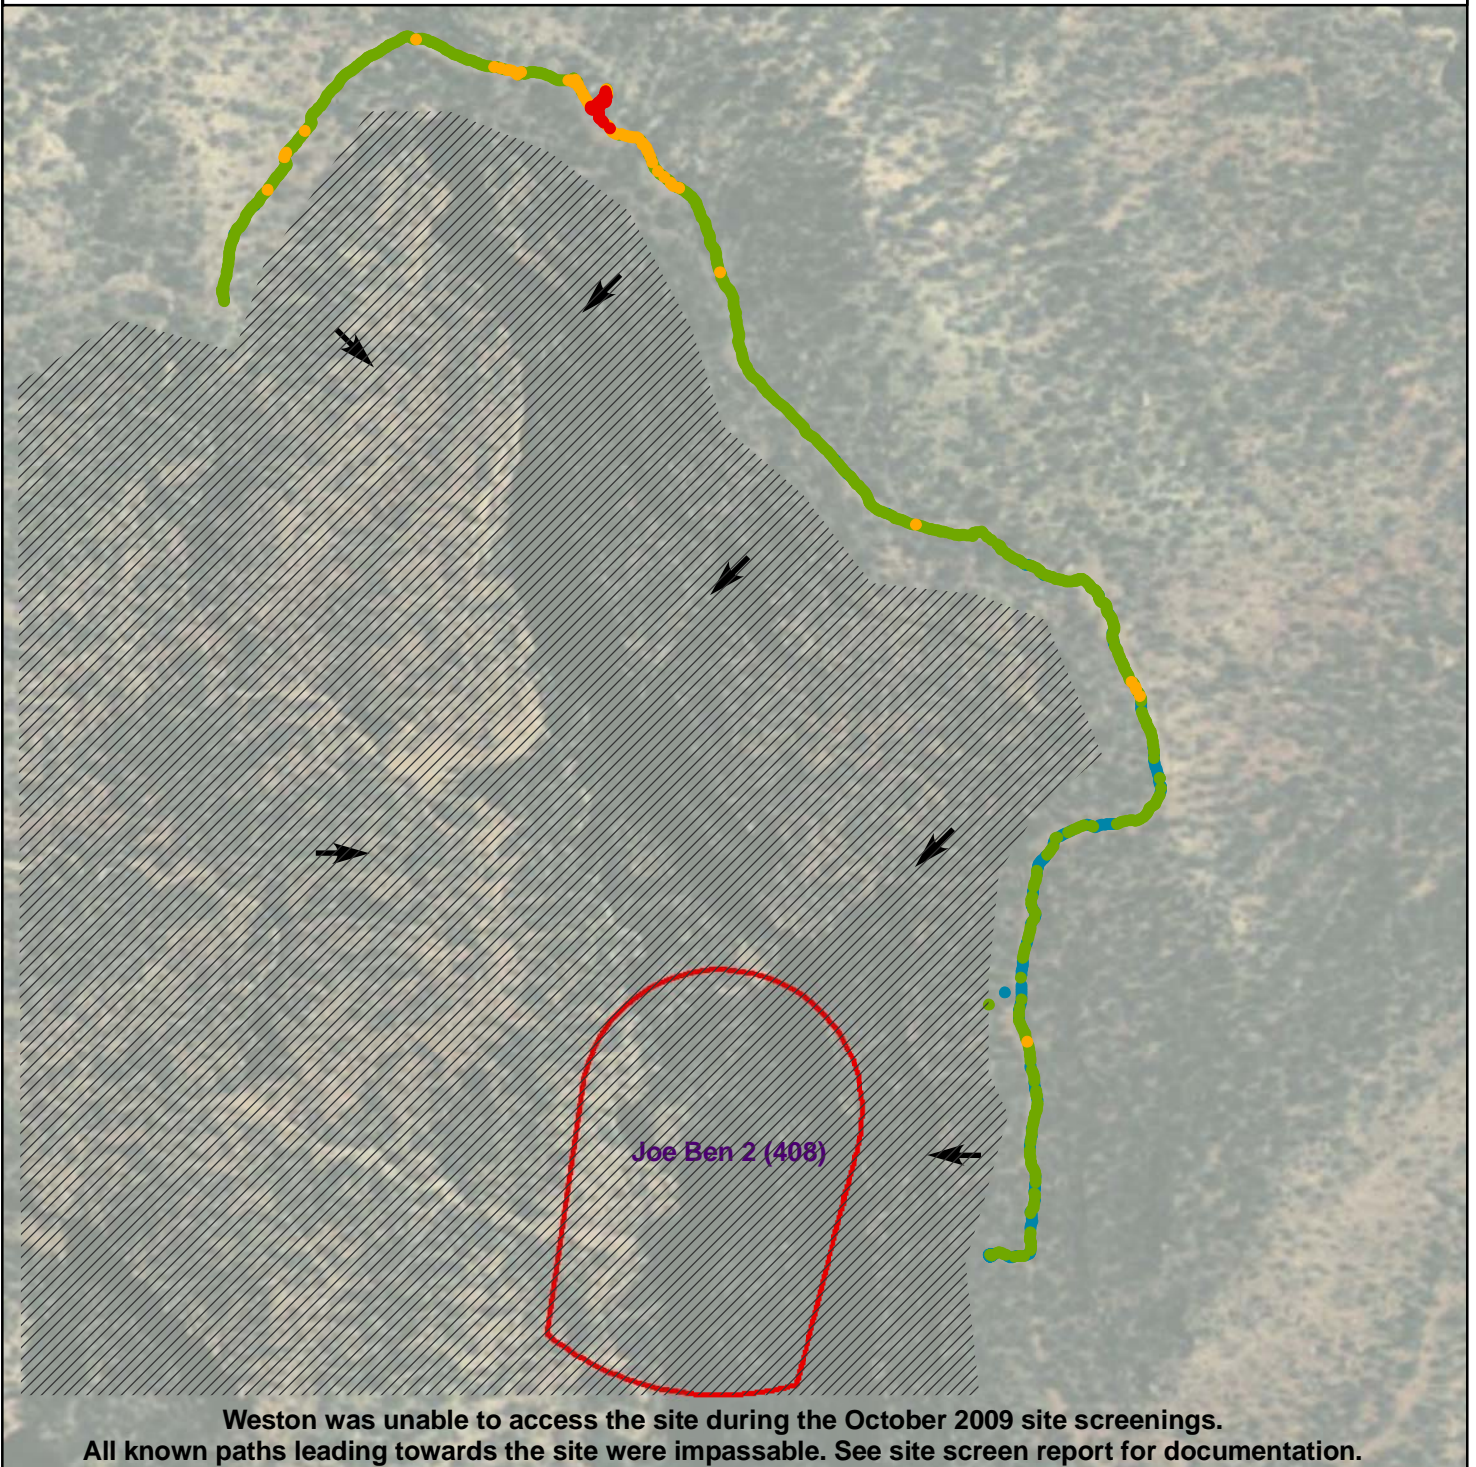
**Figure 2 - Gamma Radiation Measurements**  
**Joe Ben 2 (408)**  
**Sanostee Chapter, Navajo Nation, Arizona**

Gamma survey conducted 10/2009  
 Measured as counts per minute (cpm)

Average background = 9,300 cpm
